### 2002 & 2012 Specifications for Highway Bridges

#### **Advent of Performance-based Specifications**

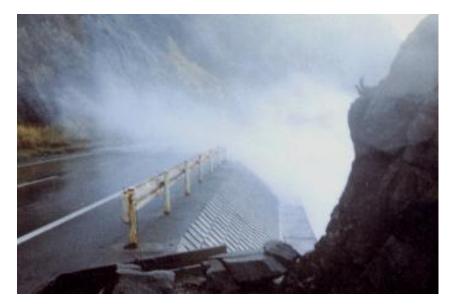
# A further protection is required for bridges built on the shoreline
